Test Summary Report

Vehicle Advertising System Trials

Carmelion Ltd
Kentish Barn
Forge Lane
East Farleigh
Maidstone
Kent
richard@traxx.eu.com

28th January 2011

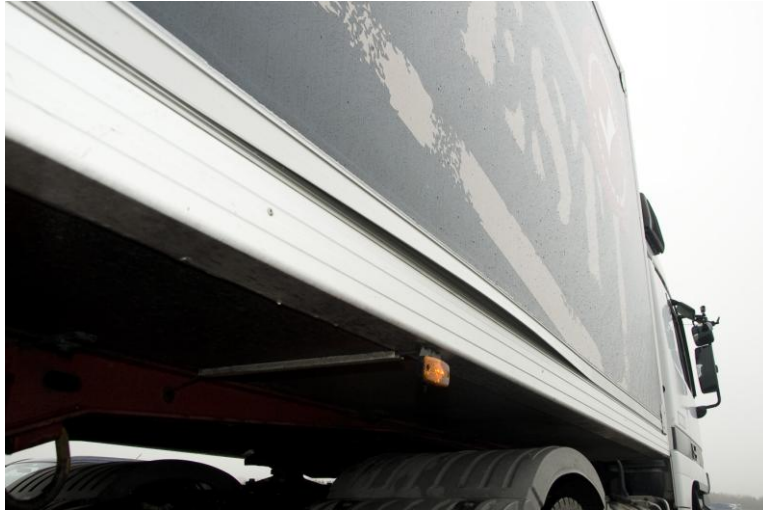
After completing two laps of the test circuit, the system was inspected for increased detachment or damage. There was no further detachment or damage to the retaining system or sign.

Test 1 Horizontal frame unclipped for 2 meter, 2 meter back from the vertical frame

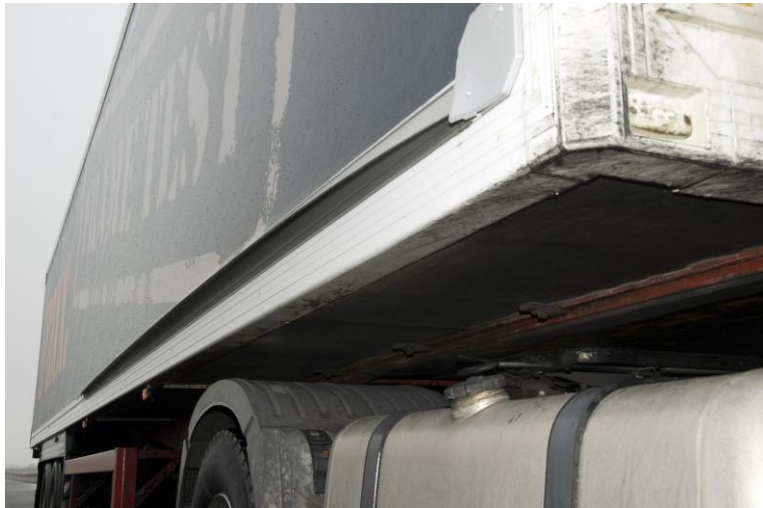
Test 2 Horizontal frame unclipped for 6 meter length

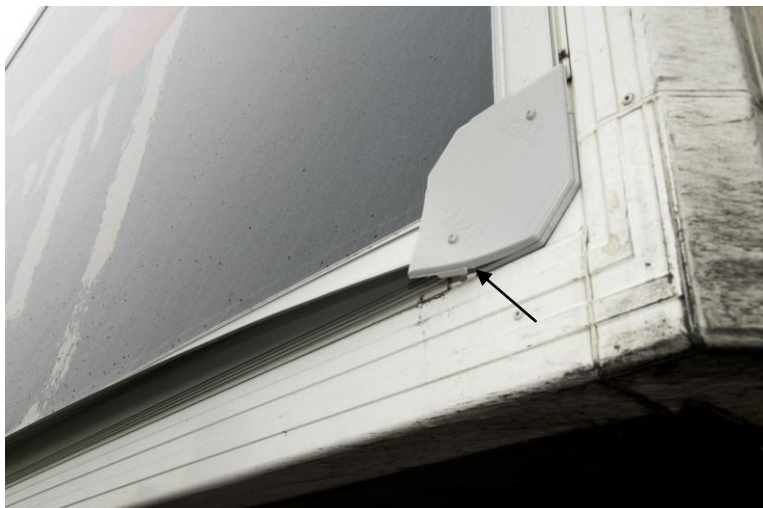
After completing two laps of the test circuit the system was inspected. The forward plastic corner cover was still retained and was holding the front of the rail against the trailer side. The lower keder section of the sign had split at the joint between the two lower rails but the next rail was still retained with no issues. The secondary retaining section of the front mounting rail was still connected to the body mounting frame.

Test 2 Lower corner cover plate retaining the horizontal frame rail after test.

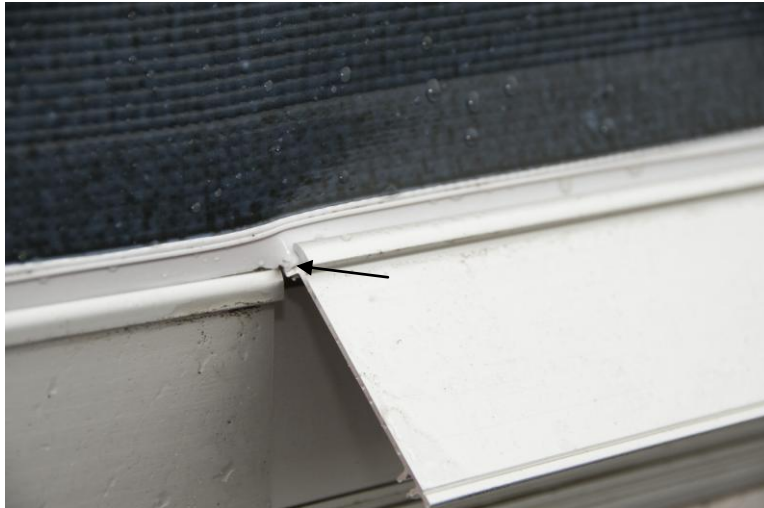
Test 2 Tear in the lower plastic section of the sign mounting system

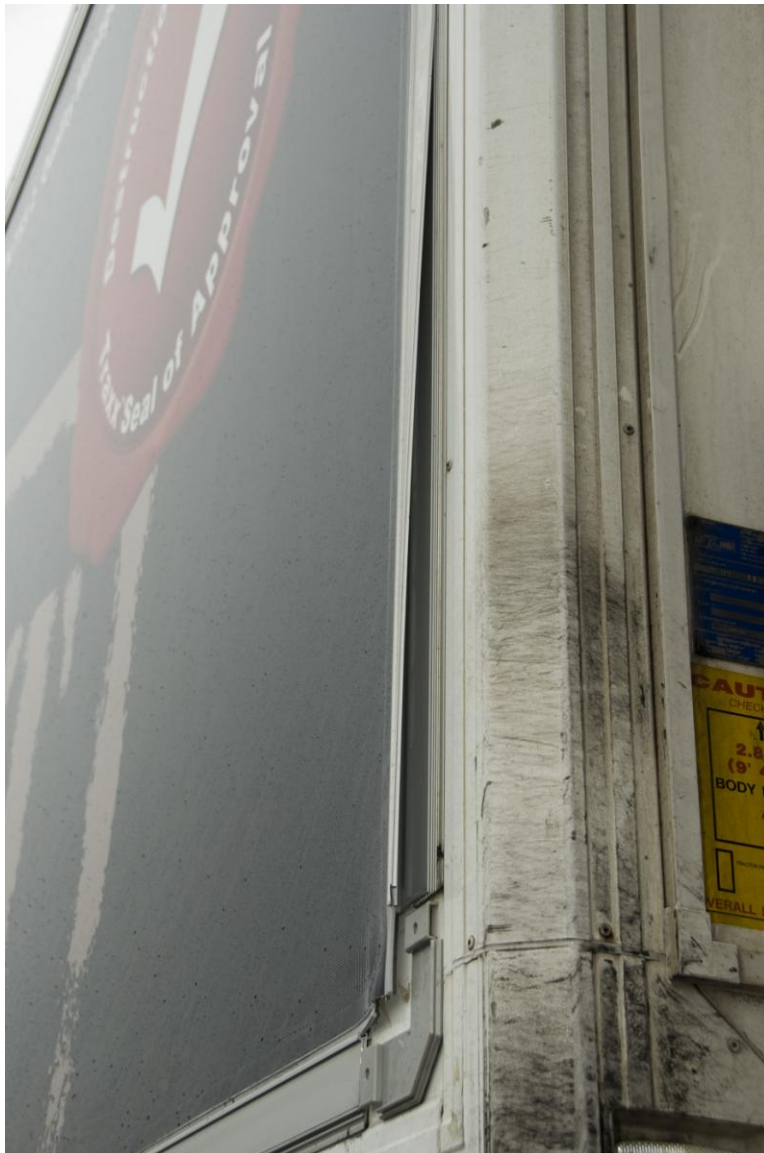
After completing two laps of the test circuit the system was inspected. There was no further unclipping of the vertical rail and no damage to the sign or lower mounting rail. The secondary retaining section of the rail was still connected to the body mounting frame.

Test 3 The horizontal frame is re-clipped and the lower corner cover plate removed. 1 meter of the vertical frame rail was unclipped from the lower corner.

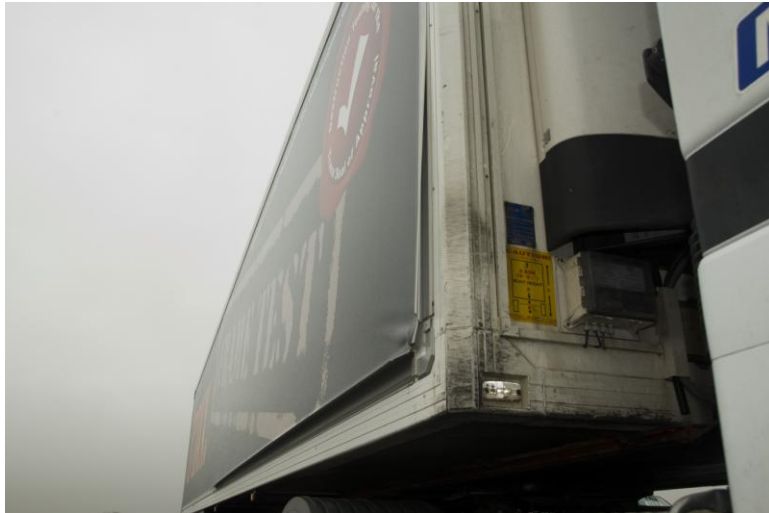
After completing two laps of the test circuit the system was inspected. There was no further unclipping of the vertical rail and no further damage to the keder.

Test 4 The horizontal lower frame was unclipped for the full 6 meters as well as the vertical frame remaining unclipped for 1 meter.

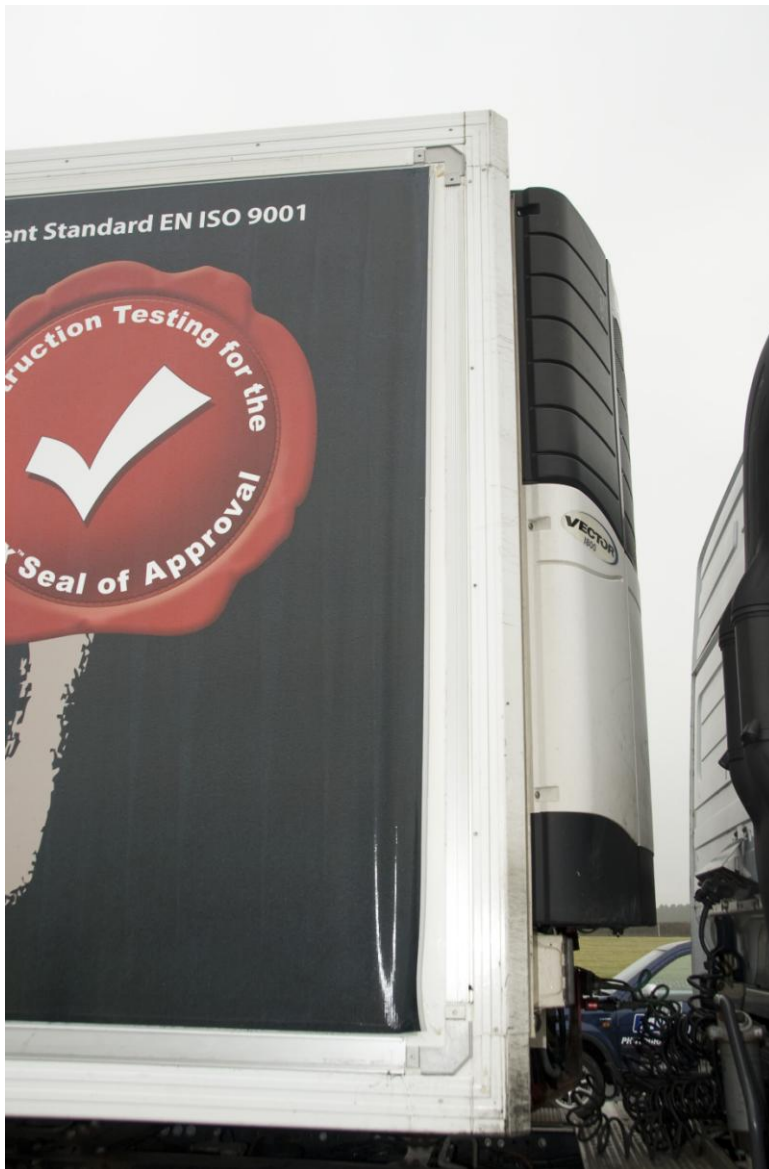
Test 5 The horizontal frame rail was re-clipped and the top corner cover plate removed. The vertical frame rail was completely removed.

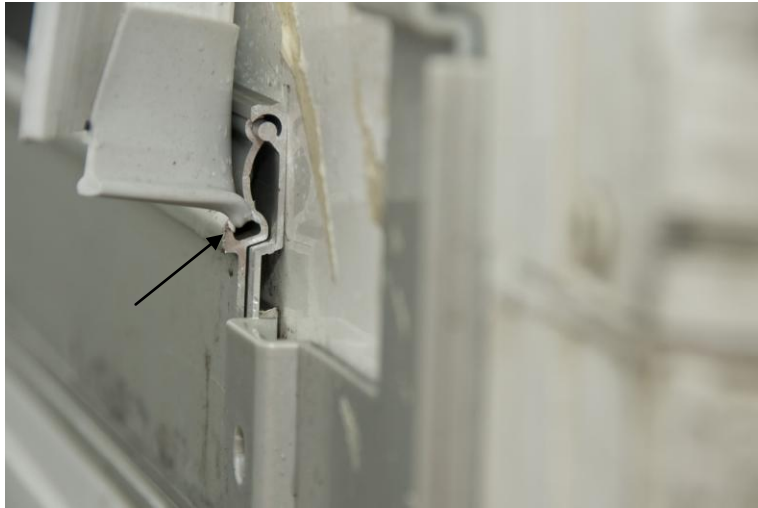
After completing two laps the system was inspected. The sign had moved rearwards in both the top and bottom mounting rails by 25mm. There was only slight damage to the lower plastic section of the sign mounting system due to contact with the bottom rail end. Due to the contact with the bottom rails the sign did not move further rearwards. If the lower mounting had not been trapped by the lower frame the sign may have travelled further rearwards in the both the upper and lower frame system.

Test 5 After completing two laps the plastic lower moulding for the sign was trapped in the lower horizontal rail.

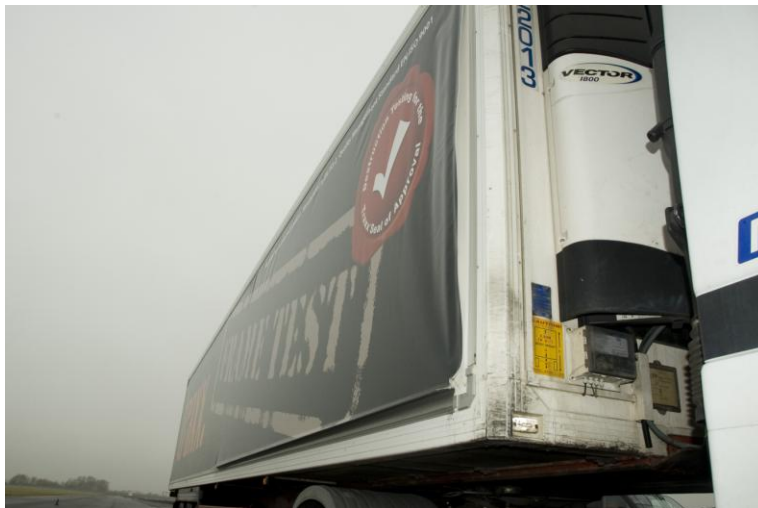
Test 6. The lower rail was unclipped for the full 6 meter length. The vertical rail was not refitted. On the first lap the secondary mounting on the lower rail became detached and the sign was bent backwards, with the lower front corner folding back over the roof of the trailer.

Test 6 The horizontal lower frame was un-clipped and the vertical rail was not refitted.

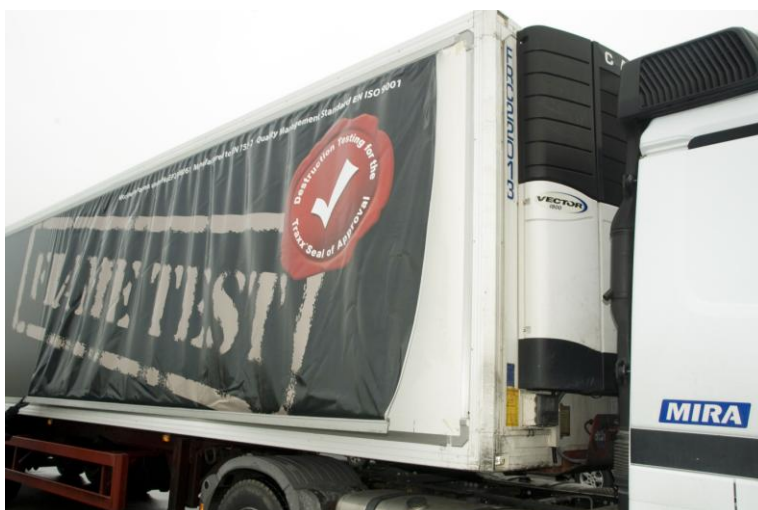
Test 6 The lower frame rail became fully detached and the sign moved rearwards in the top frame rail.

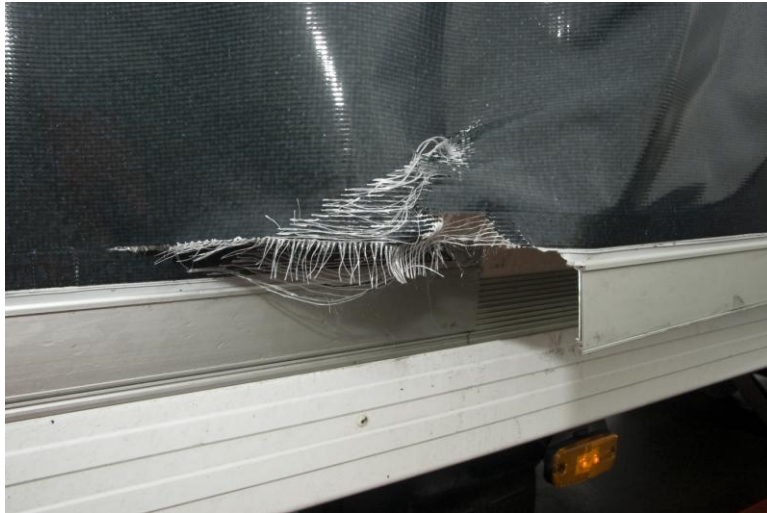
After completing two laps the system was inspected. The top of the sign had moved rearwards in the top rail by approximately 120 mm. Where the rear section of the lower rail had retained the sign the material had torn for approximately 320 mm. The sign was pulled forwards and all the fixing rails were refitted and clipped. With the exception of the tear at the lower rail joint there was no damage to the fixing system or the sign after the frame tests.

Test 6 The sign material tore at the attached rear lower horizontal frame

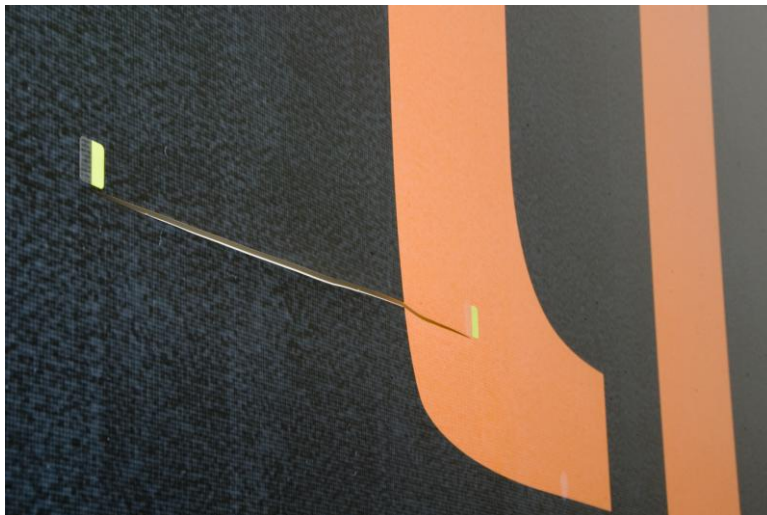
After completing two laps of the test circuit the sign was inspected. There was no increase in the cut length.

Test 7 Horizontal cut of 500 mm, 500 mm rearwards of the front frame and 500 mm above the horizontal lower frame

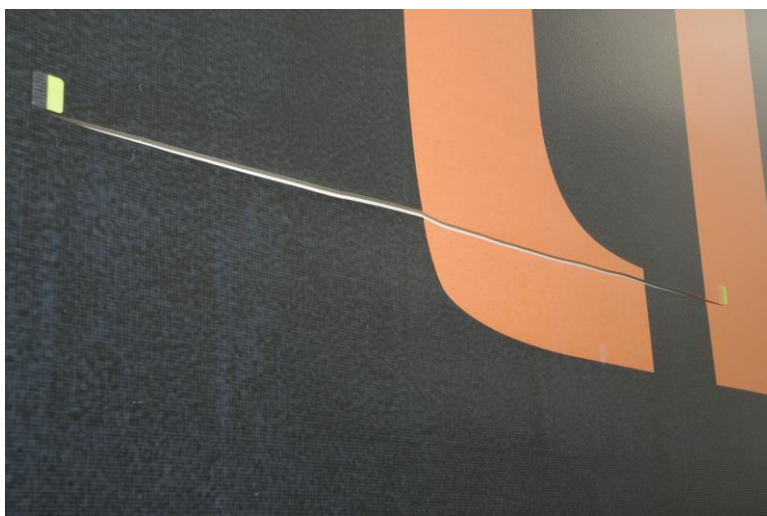
After completing two laps of the test circuit the sign was inspected. There was no increase in the cut length.

Test 8 Horizontal cut extended to 1 meter

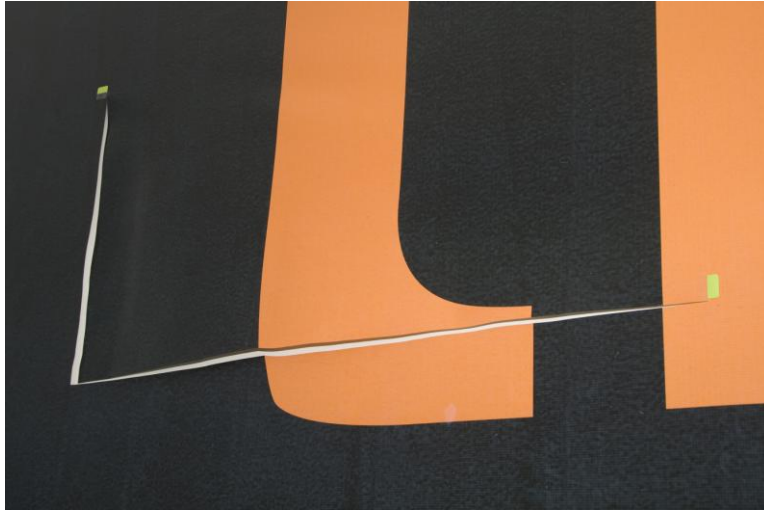
Test 9 Vertical cut for 500 mm from the front of the 1 meter horizontal cut

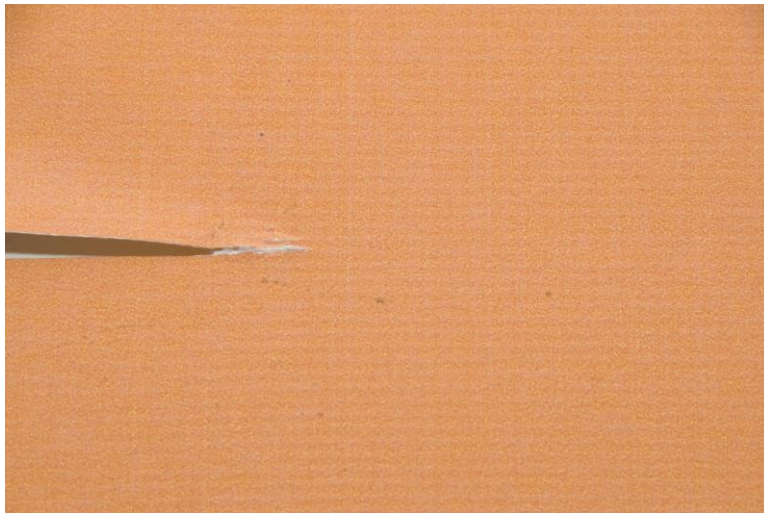
After completing two laps of the test circuit the sign was inspected. There was a tear of 12 mm at the end of the horizontal cut and a delaminating of the sign surface coating for a further 10 mm. There was a tear of 10 mm at the end of the vertical cut.

Test 9 12 mm tear at the end of the horizontal cut with 10 mm delaminating of the material surface coating

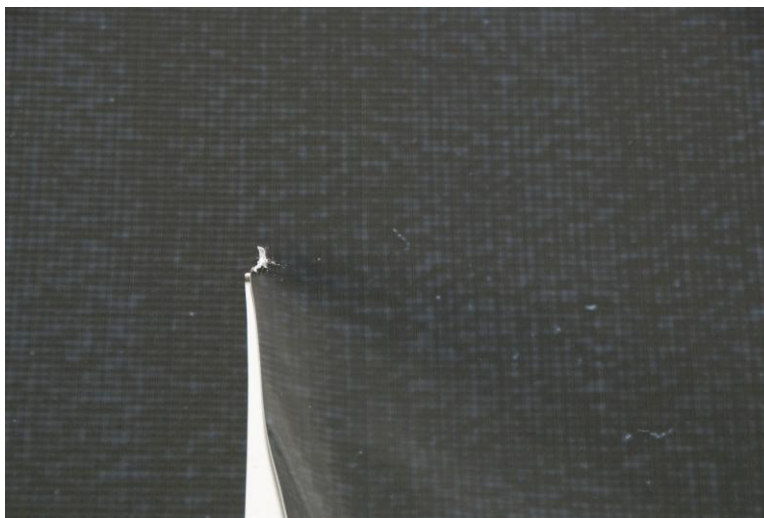
Test 9 10 mm tear in the end of the vertical cut

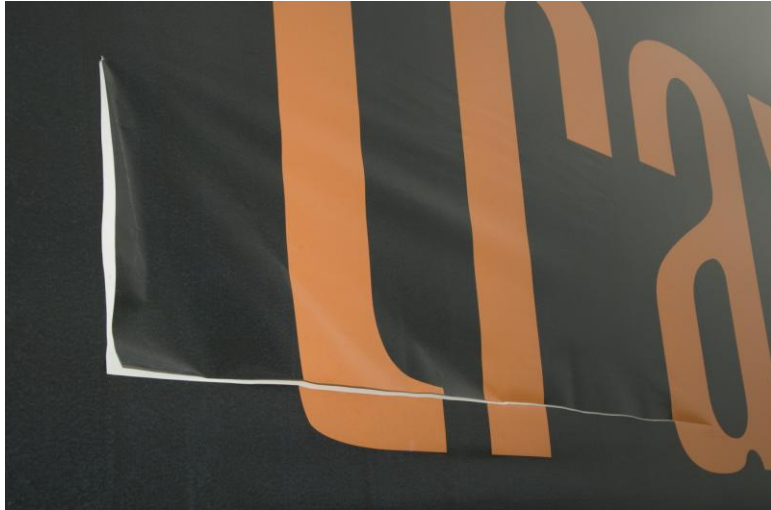
After completing two laps of the test circuit the sign was inspected. There was no increase in the tear at the end of the vertical cut. There was separation of the surfaces coating from the backing of 2.5 mm at the end of the horizontal cut.

Test 10 The horizontal cut extended to a length of 2 meters

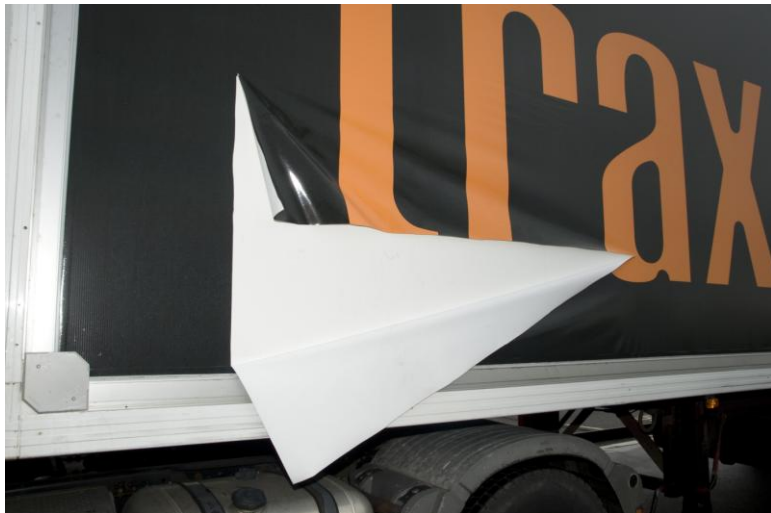
Test 11 The vertical cut was extended down to the lower horizontal frame rail

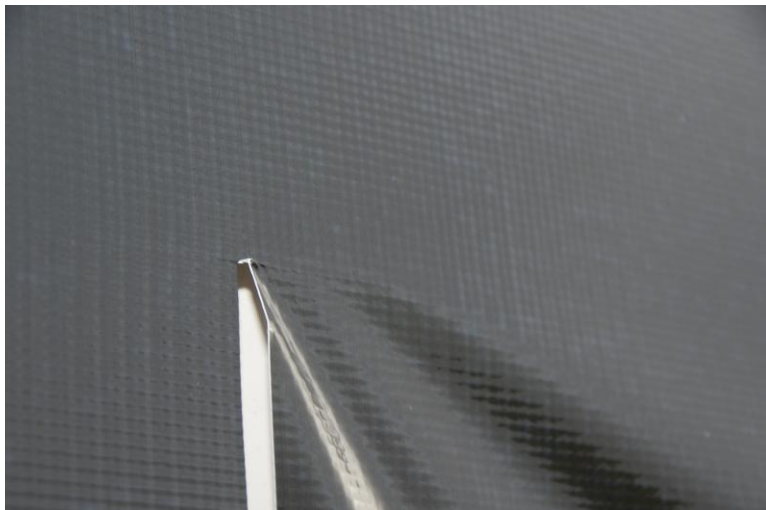
After completing two laps of the test circuit the sign was inspected. The tear at the top end of the vertical cut had extended to 12 mm and the delaminating at the end of the horizontal cut had increased to 5 mm.

Test 11 The tear at the top of the vertical cut extended by 2 mm

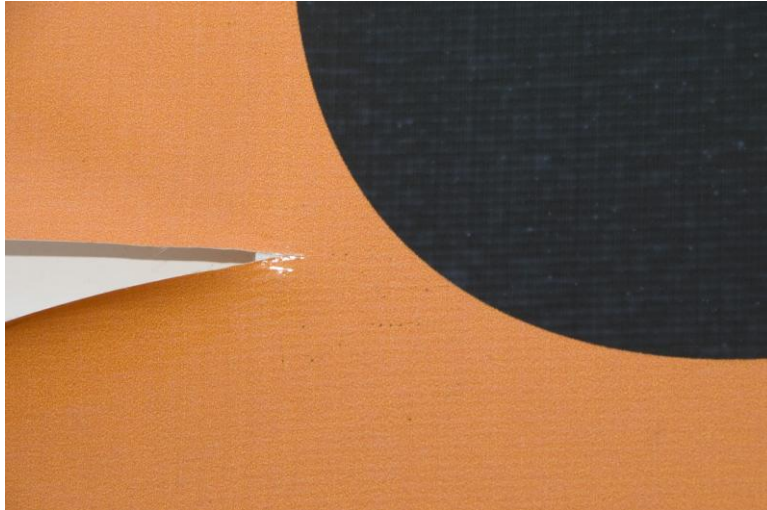
Test 11 12 mm delaminating at the end of the horizontal cut

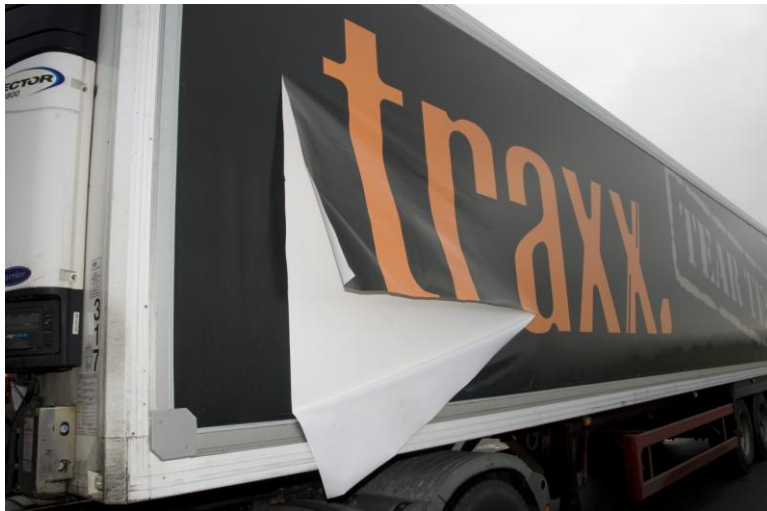
After completing two laps of the test circuit the sign was inspected. The top of the vertical cut had torn for 2.5 mm and there was delaminating of 1 mm. There was no additional delaminating or tearing to the horizontal cut.

Test 12 The vertical cut was extended by 500 mm to a length of 1.5 meters

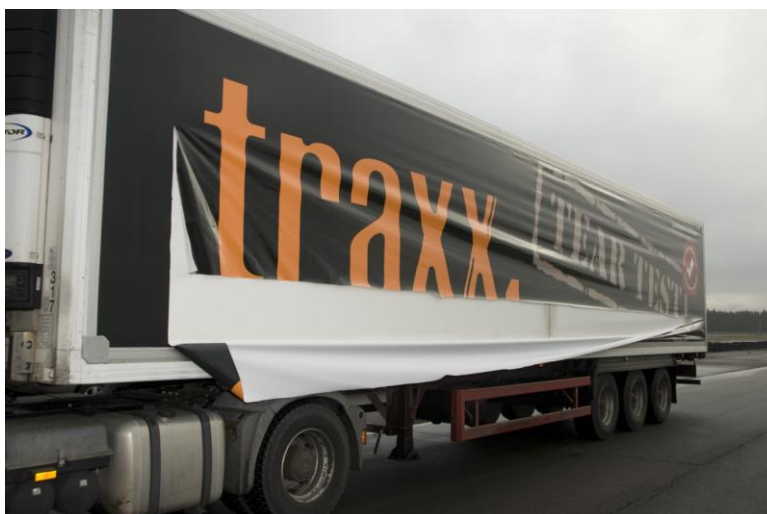
After completing two laps of the test circuit the sign and the mounting rails were inspected. There was no further damage to the sign and the lower mounting frame was still attached.

Test 13 The sign was cut for the full length of the trailer.

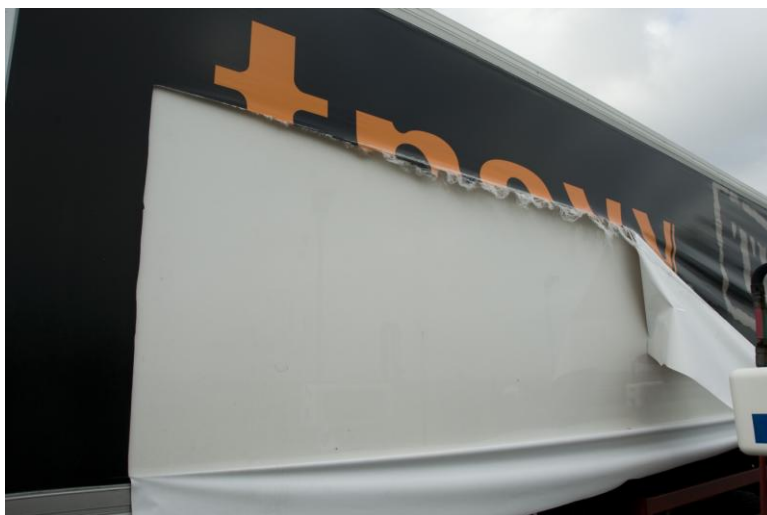
Test 15. On completion of all the tests the sign was subjected to a vandalising test. This was carried out by physically tearing the lower corner of the vertical knife cut rearwards. This proved to be very difficult and required two people to complete a tear of approximately 6 meters. The resulting tear showed numerous threads from the backing material and did not progress in a continuous horizontal line indicating that the backing material failed randomly between each weft and warp.

Test 15 The sign material was physically torn rearwards from the knife cut to emulate typical vandalism.
